# Manhole Inspection Summary

Manhole # S21CC\_010MH

Insp Date: **10/24/07 1:15 PM**

**Location** Address: **1833 RIGGS-ALLEY-MOSHER** Cross Street: **MONROE-MCKEAN**

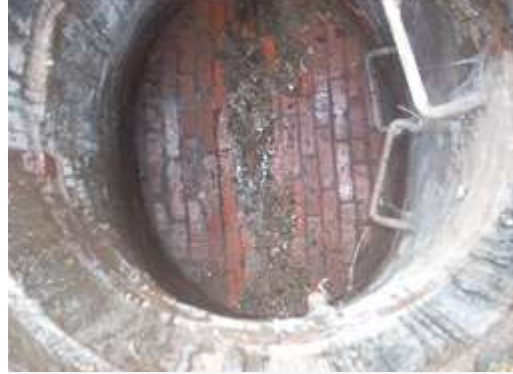
Top View

DEBRIS IN CHANNEL

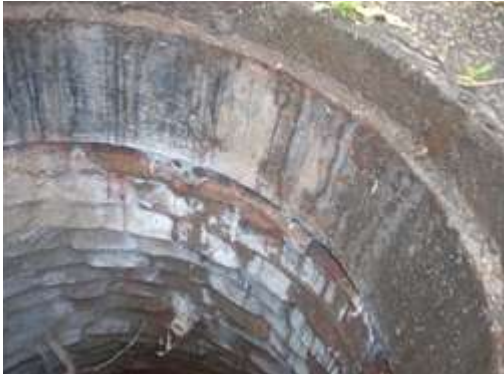
Defect 1

**Chimney / Frame Adjustment** ☒ Exists Material: **Brick** ☐ Parged Height: **3** (in.)  
Condition: ☐ Sound ☐ Cracked ☐ Root Intrusion ☒ **Loose Brick** ☐ Deteriorated  
Infiltration: ☒ None ☐ Joint ☐ Cracks ☐ Mortar ☐ Roots ☐ Wall

LOOSE CHIMNEY BRICKS

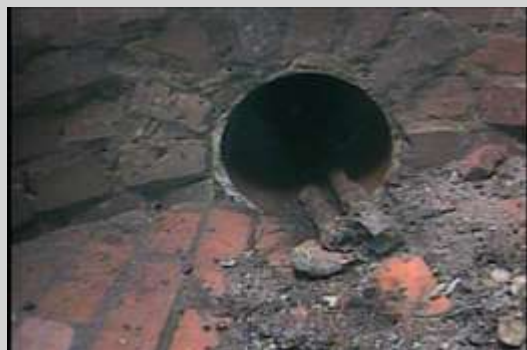
12 O'Clock Outflow

8 in. Circular Gravity Sewer  
Pipe Out @ 12 O'Clock

Infiltration: **None** Pipe Seal Cond: **Sound**
